# US 36 Flood Recovery

*Emergency and Permanent Repairs from  
Estes Park to Lyons*

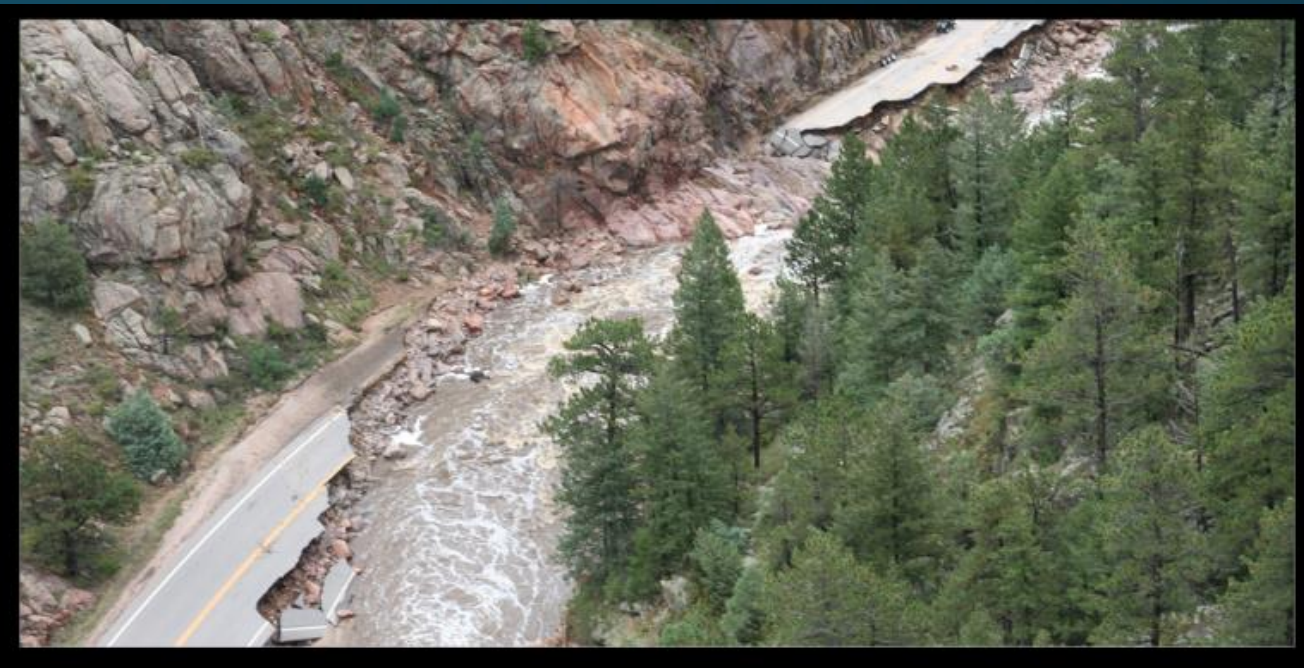
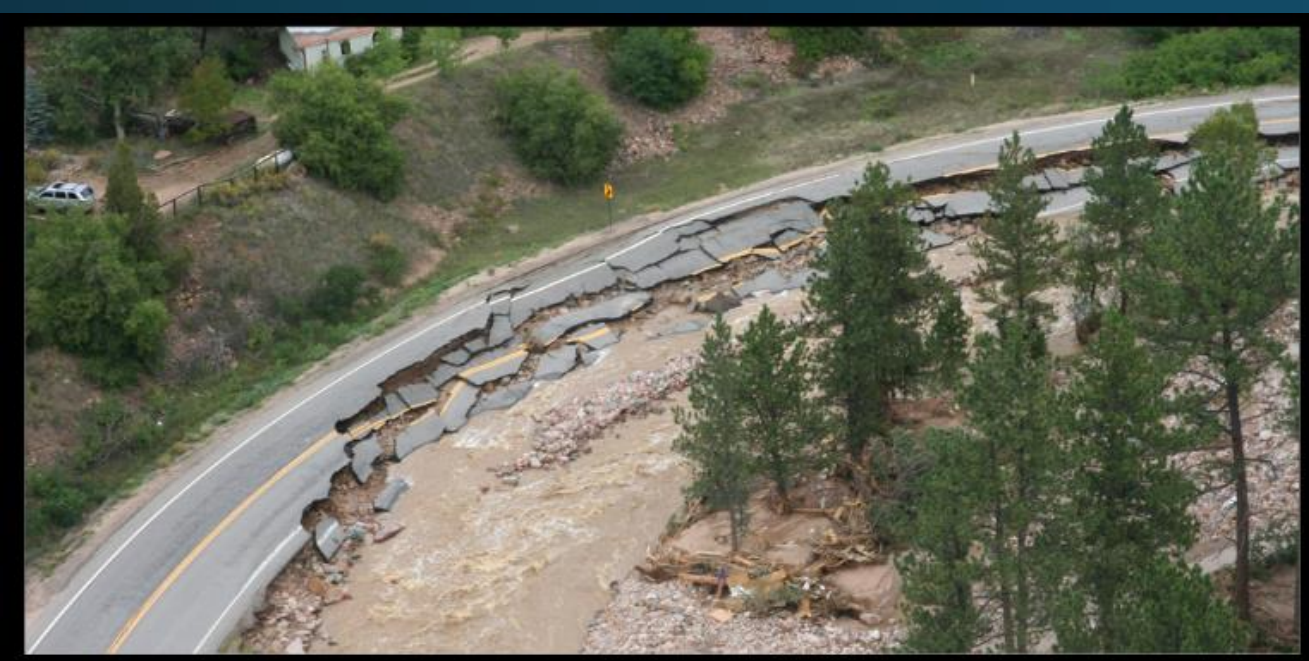
- 17 damaged sites from MP 7.7 to 18.6 were identified
- The river undermined the roadway embankment, in some places down to bedrock
- The washouts caused road sections, including asphalt, road base, guardrail, and signing, to collapse into the river
- Massive debris fields of uprooted trees, cars, river rock, sand, and a collection of private property from flooded houses were left in the river beds

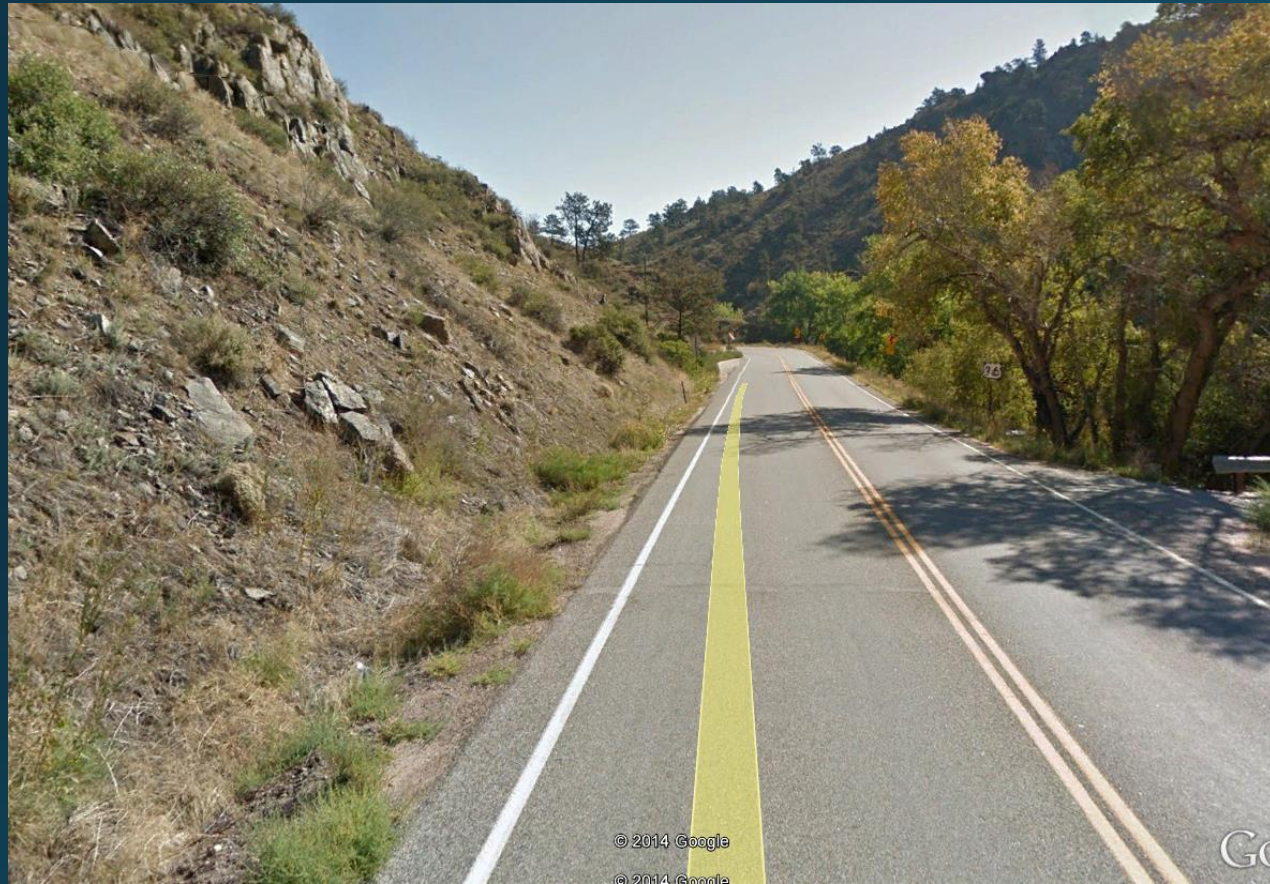
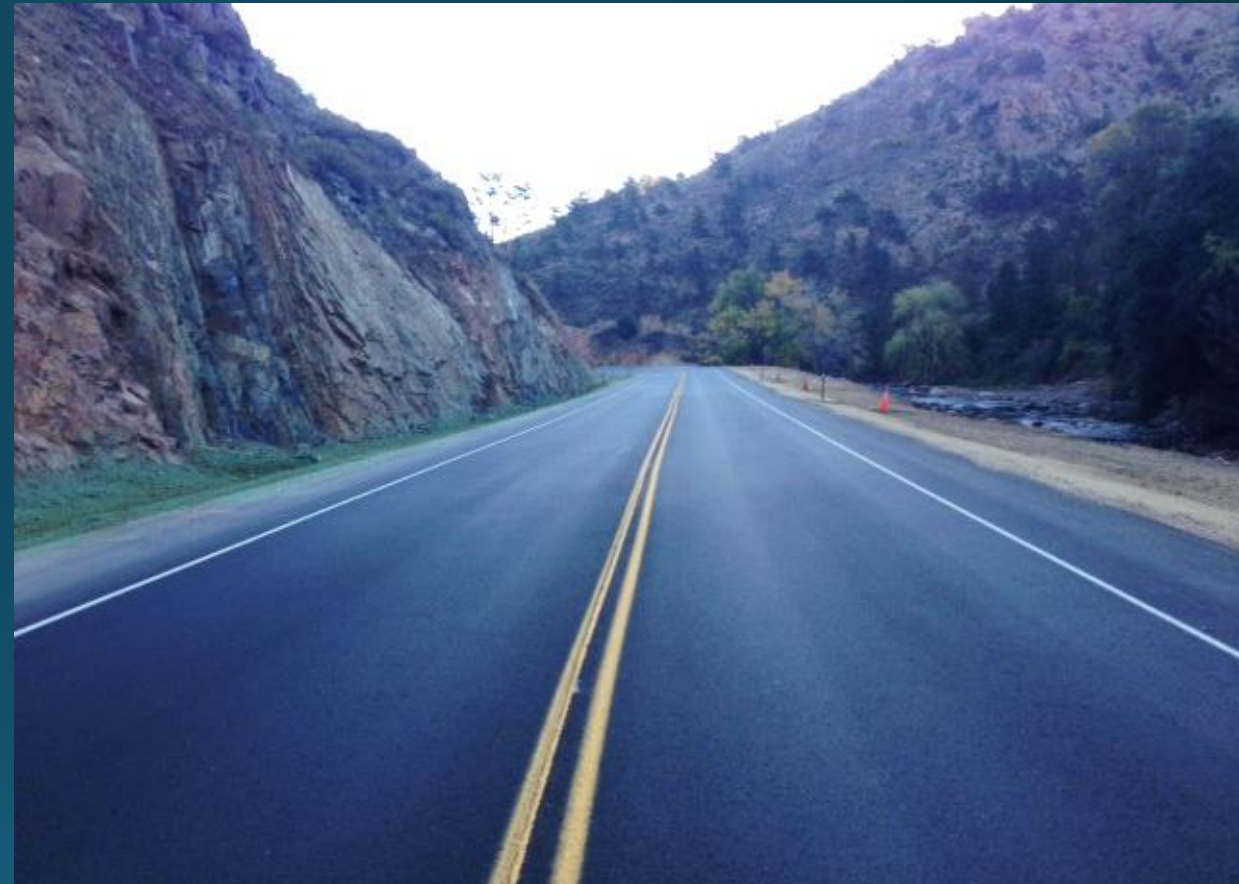
**BEFORE**

**AFTER**

Increased safety by:

- Added 6' shoulders in each direction
- Added 10' rock fall ditch to catch falling rocks from mountainside

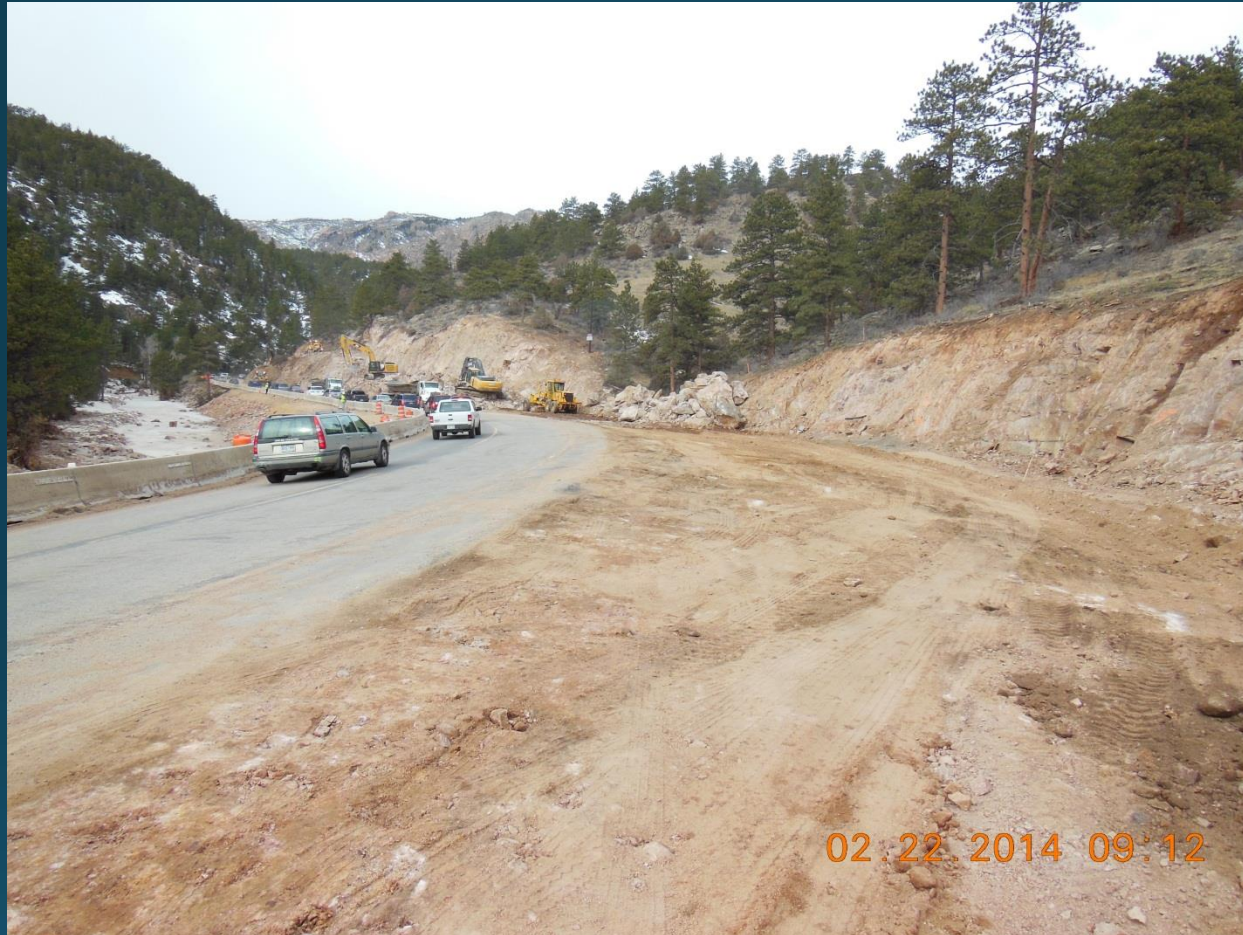
Shifted 5'-60' (average of 20') towards the mountainside

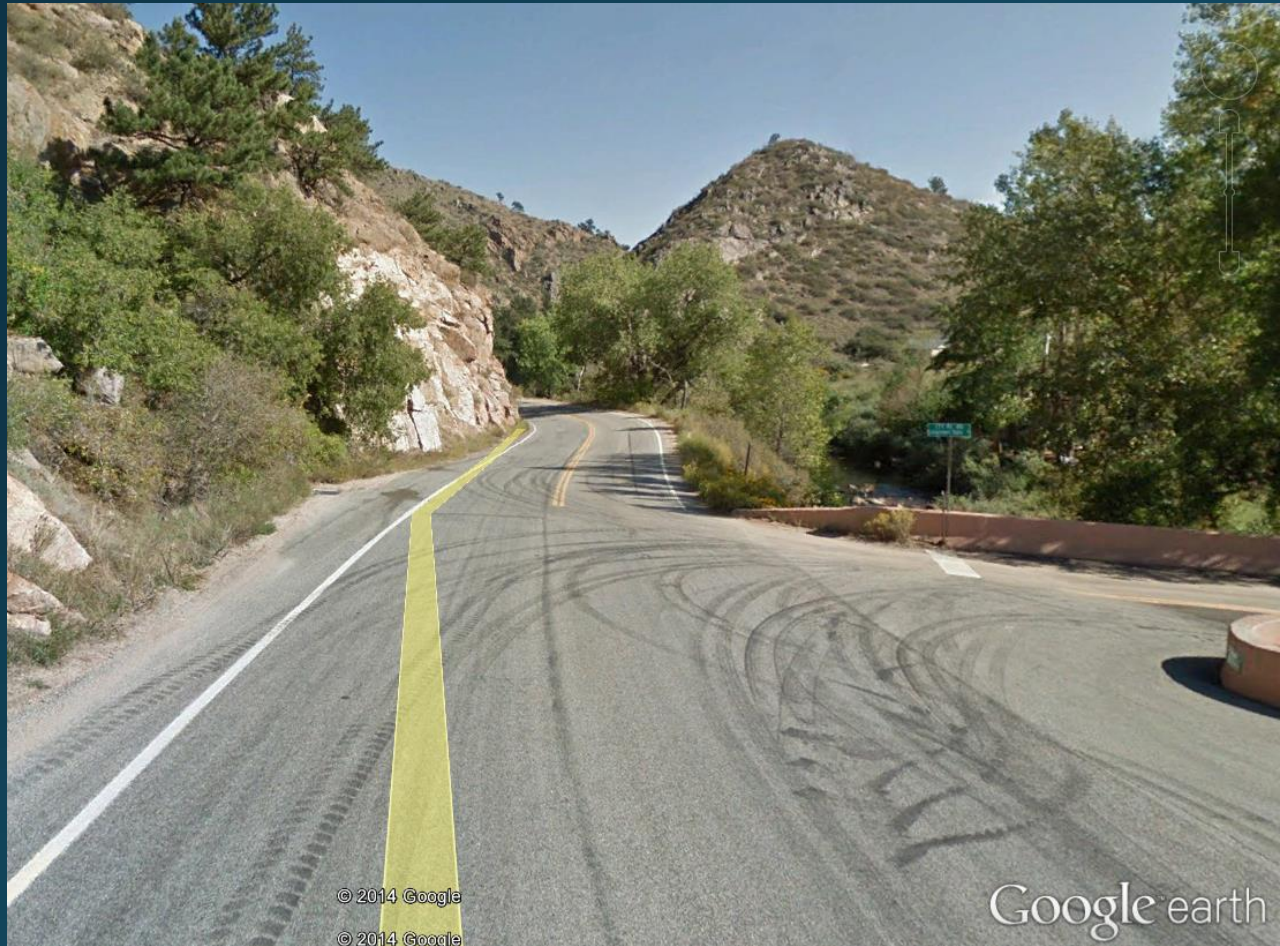
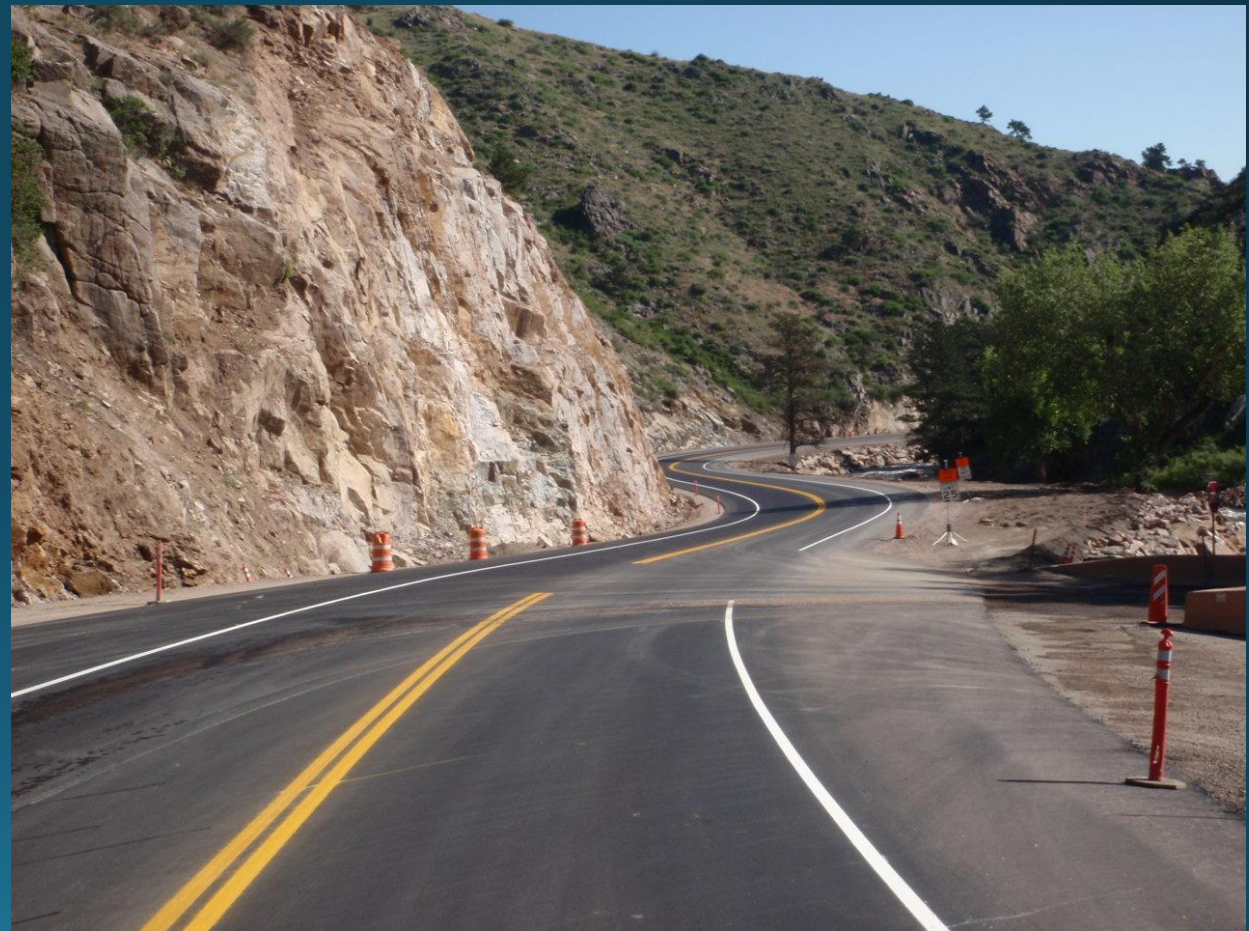
Softened the Curves

**BEFORE**

**AFTER**

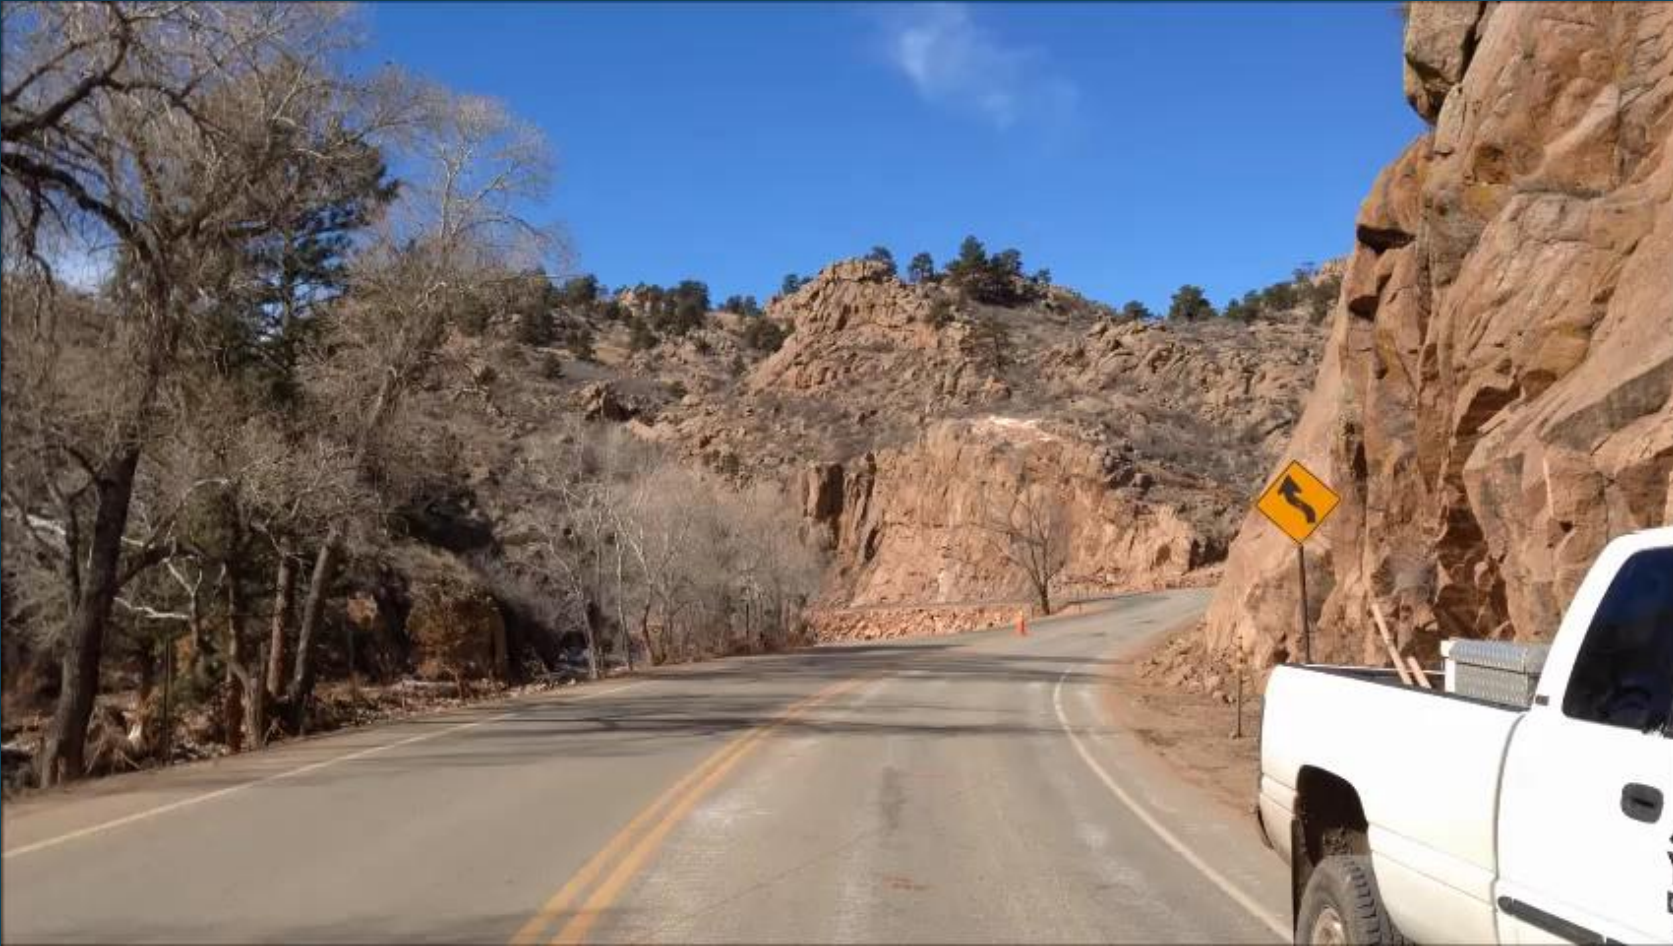
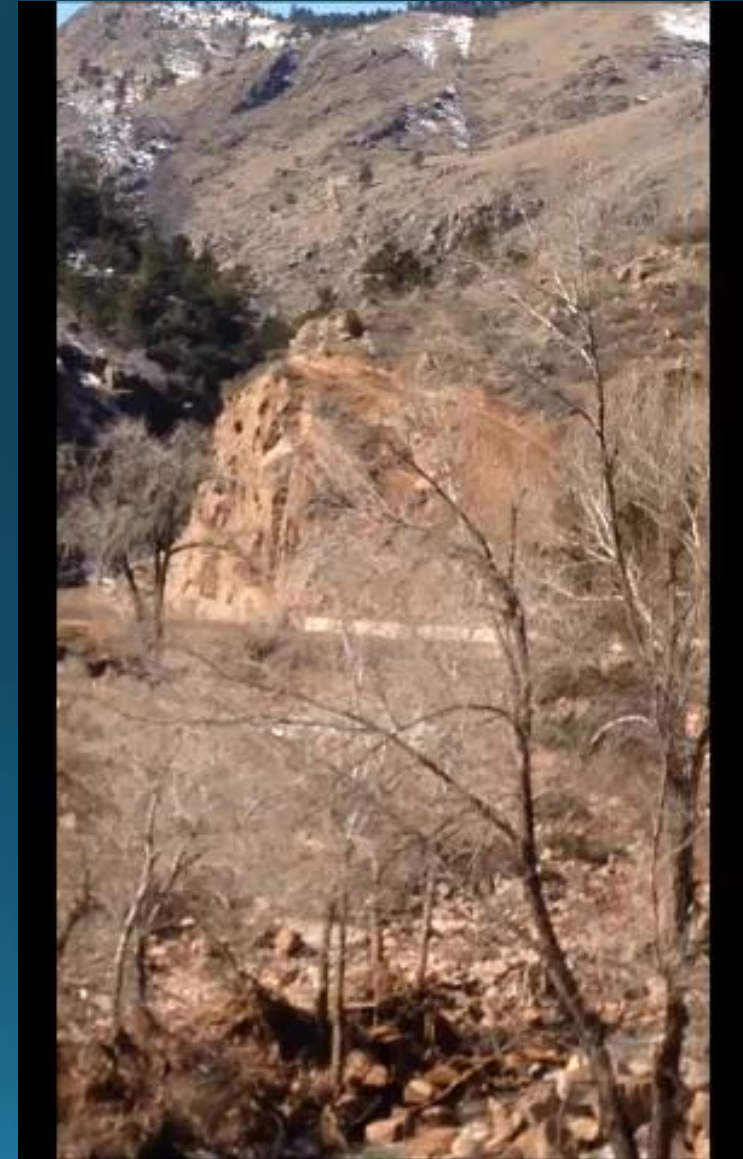
- Approximately 250,000 cubic yards of granite was removed
- Two work zones totaling almost two mile blasting length

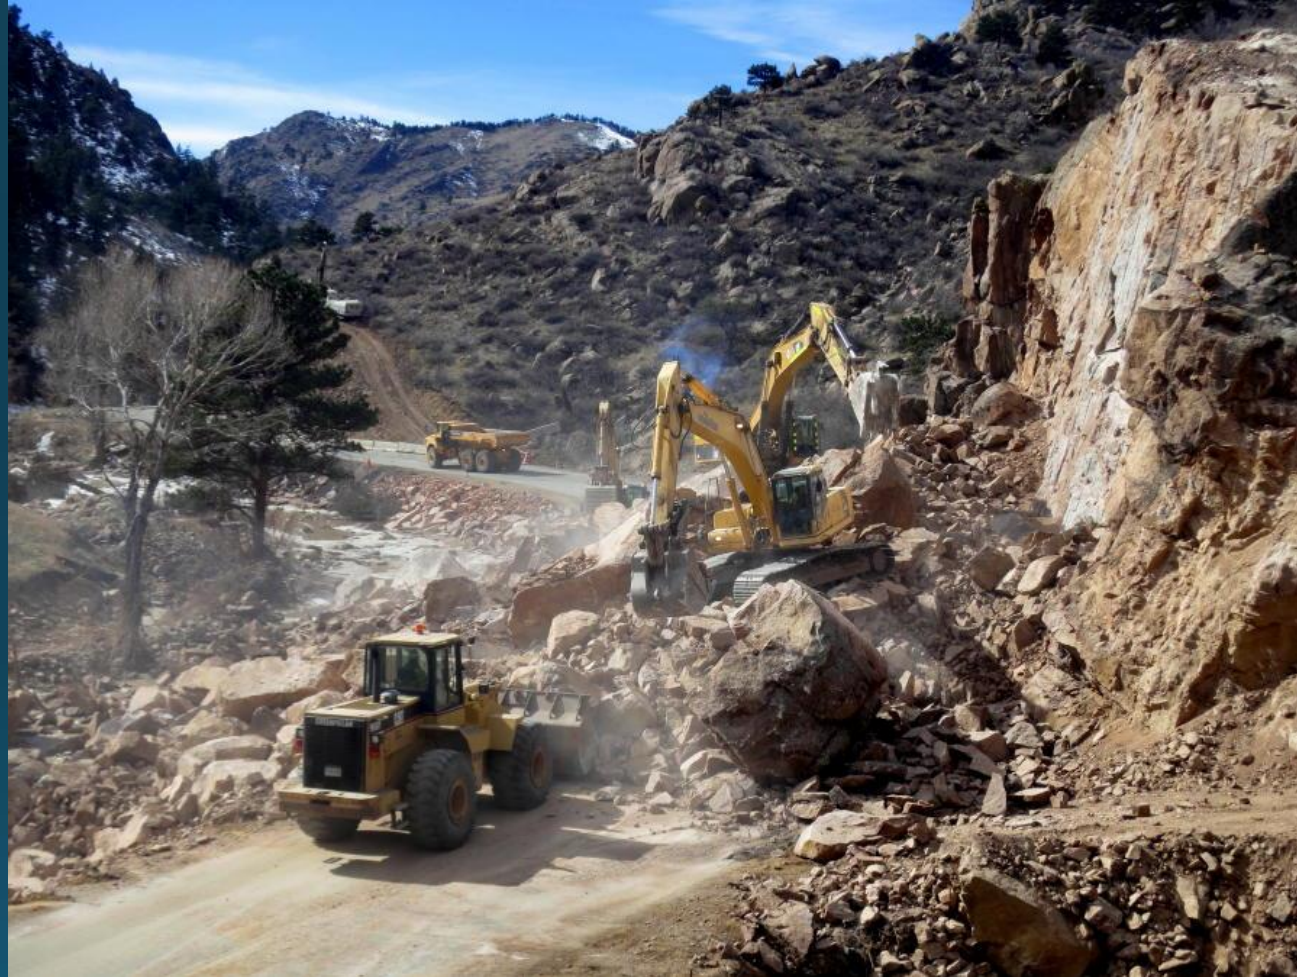
This picture represents about 2% of the material that was moved by May

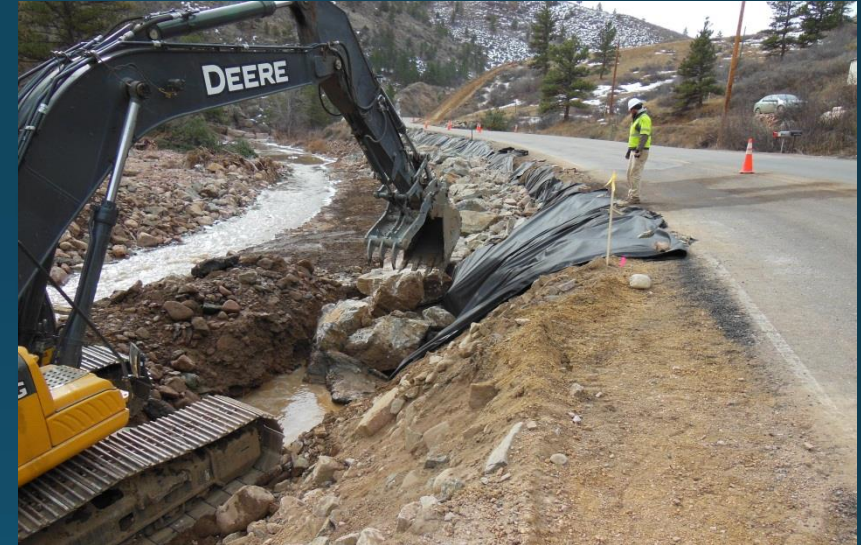
- Needed to armor before spring runoff because road was at risk
- Used material from blasting (large 5'-8' rocks)
- Keyed into bedrock at bottom of the river
- Spot grouted inside to lock in place

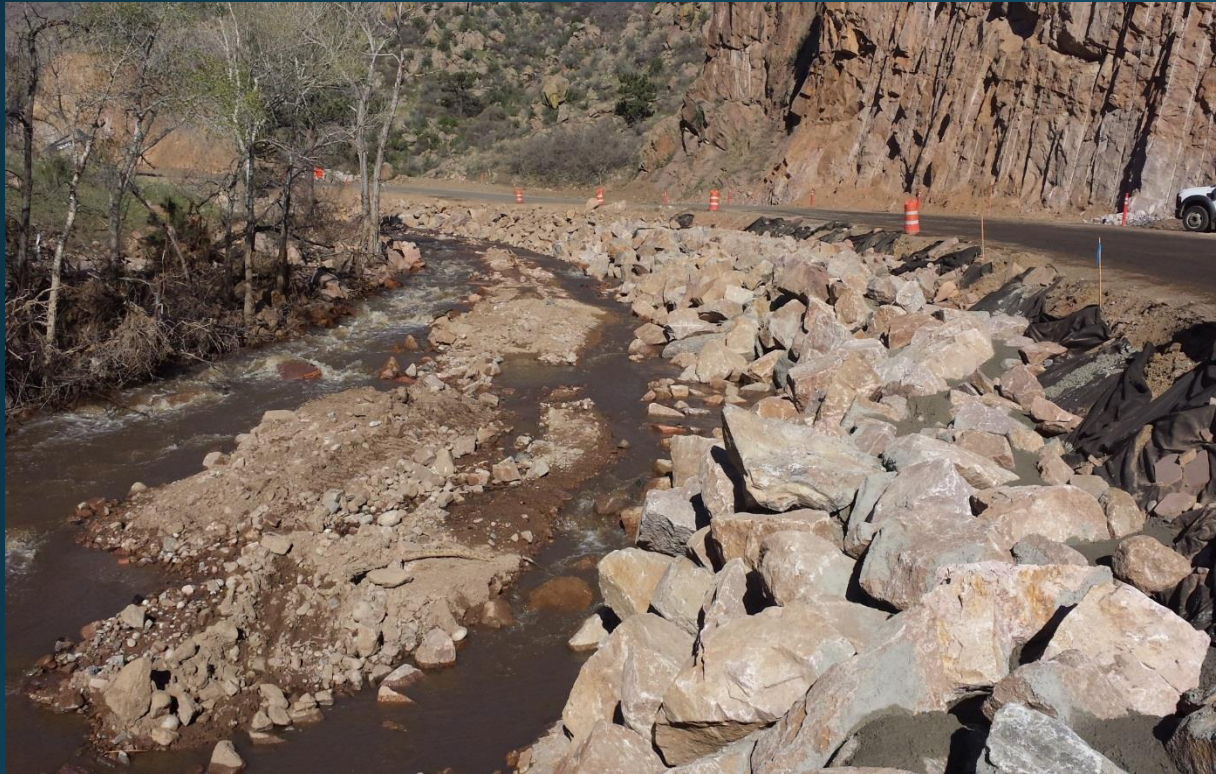
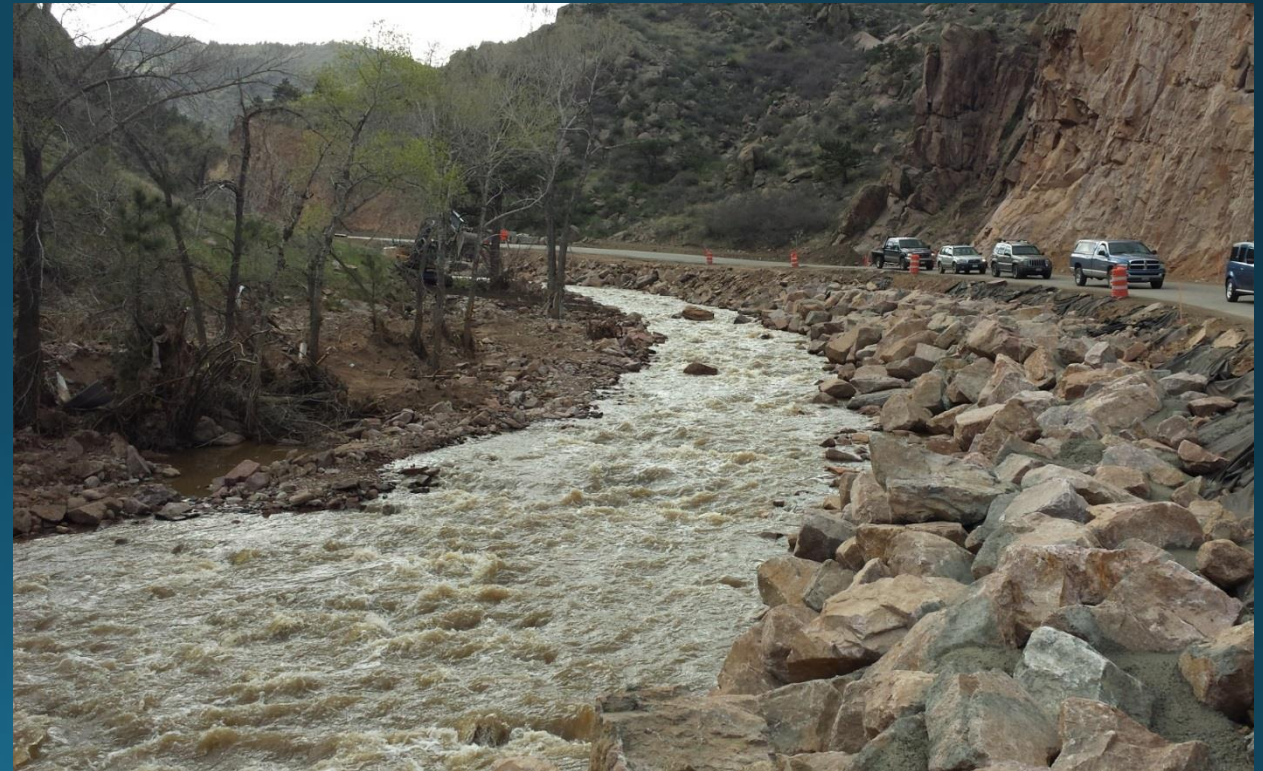
BEFORE

AFTER

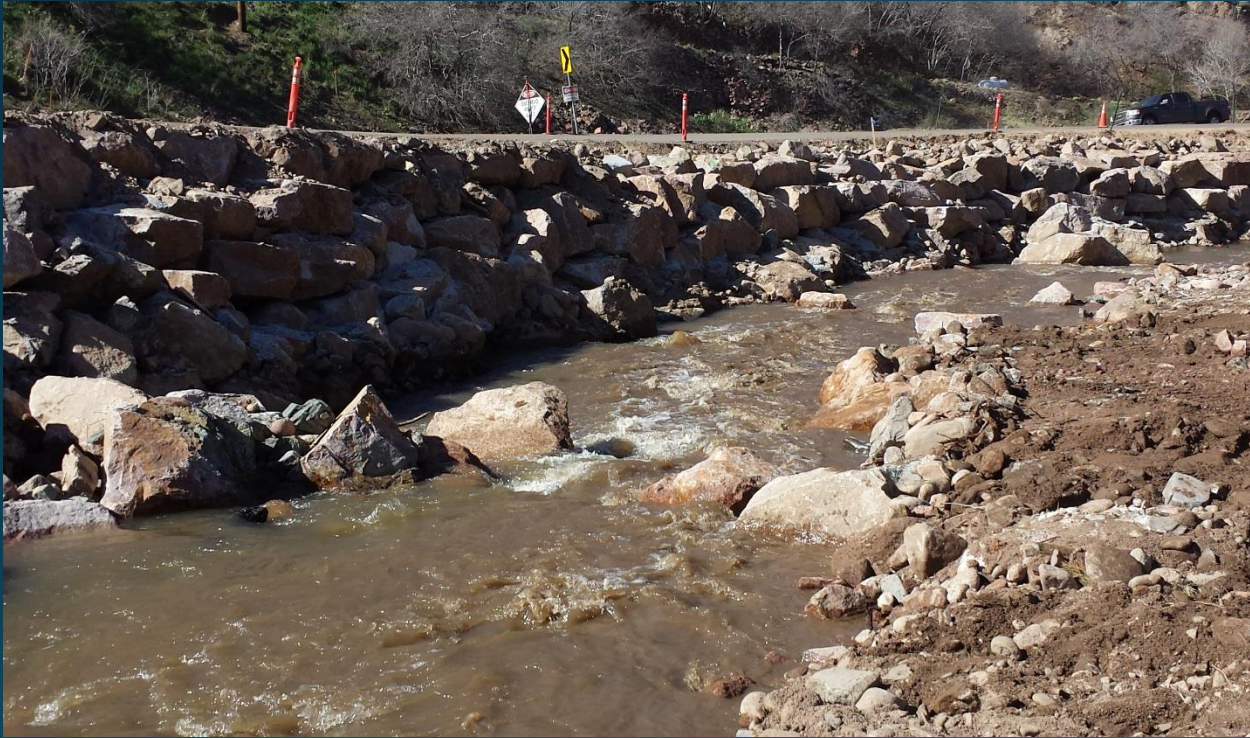
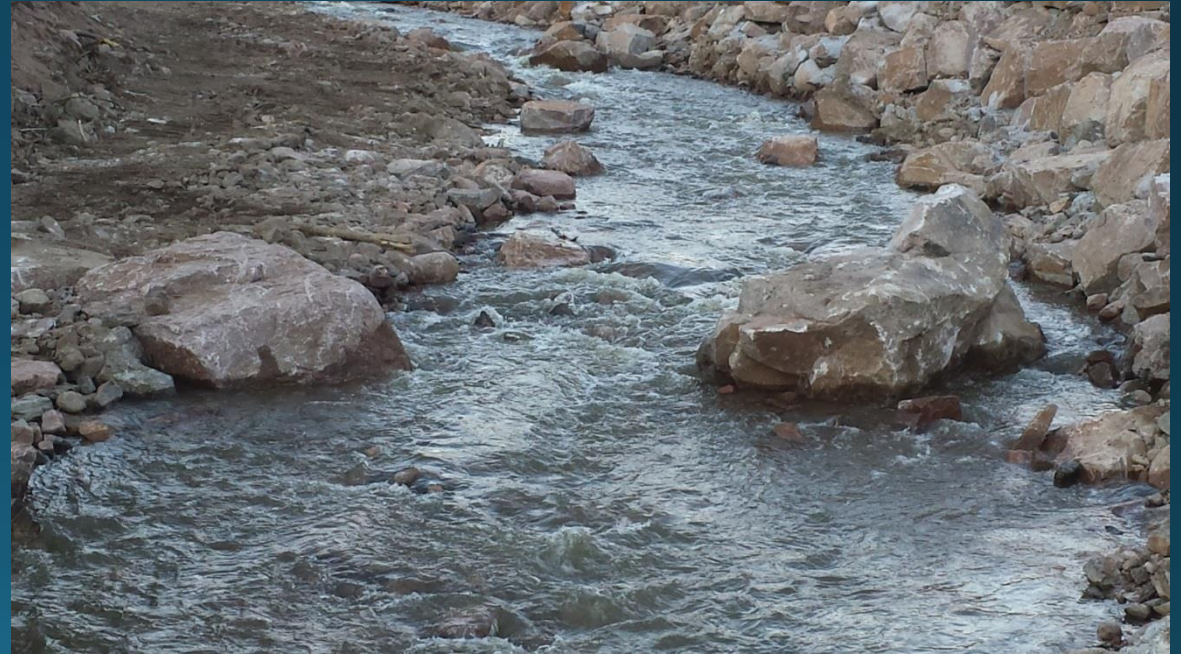
- Used Boulder clusters, large woody debris, and meandering low flow channels
- Mitigate undercutting and destruction from flood event
- The lower 20% of the river carries the highest velocity and can cause the most destruction

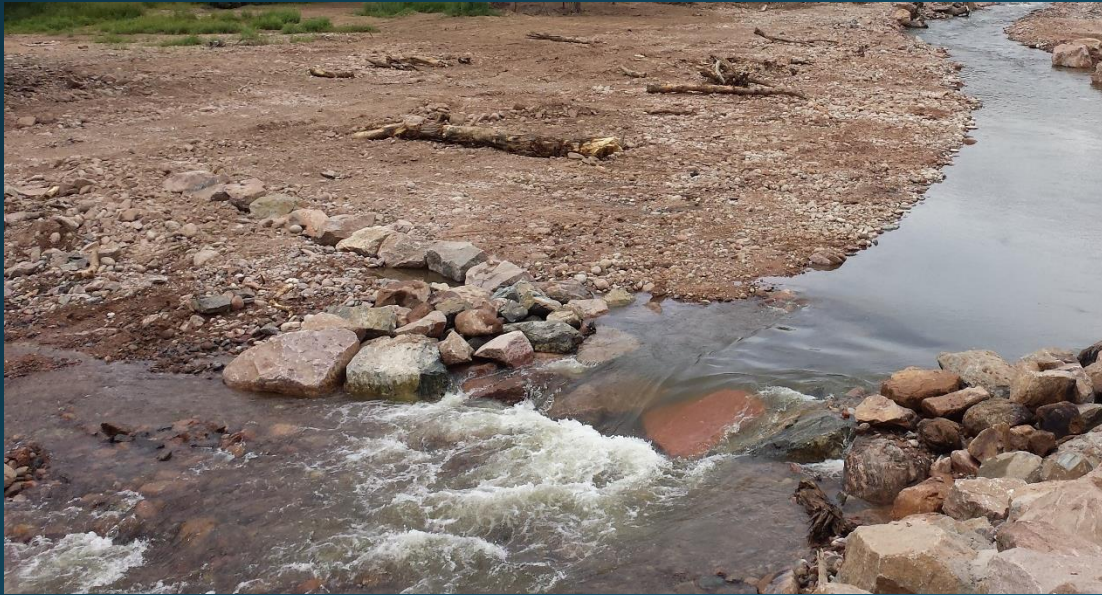
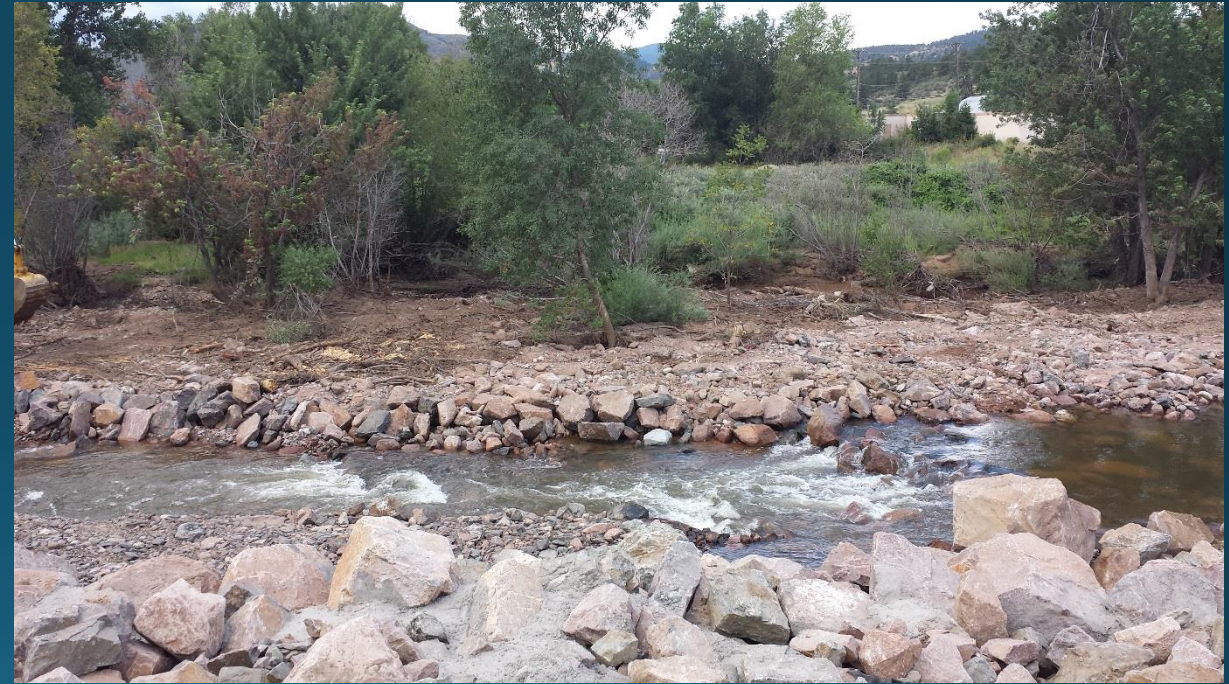
- Constructed at most sites to reduce the width to depth ratio of the low flow channel
- Increase floodplain capacity while adding complexity to the channel
- Used large buried rocks and logs

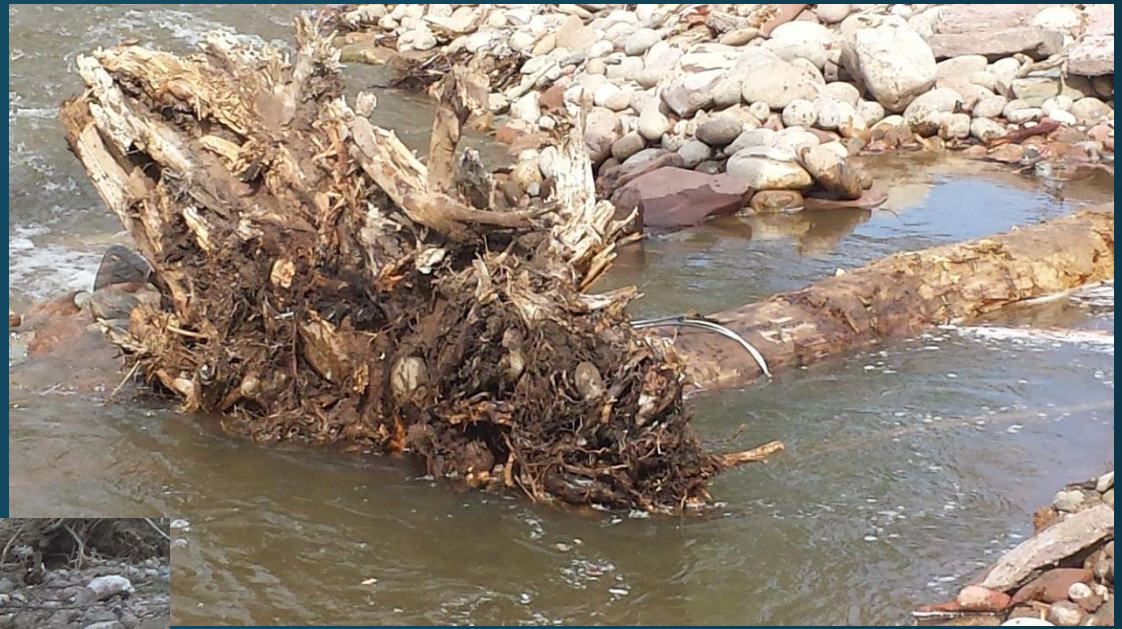
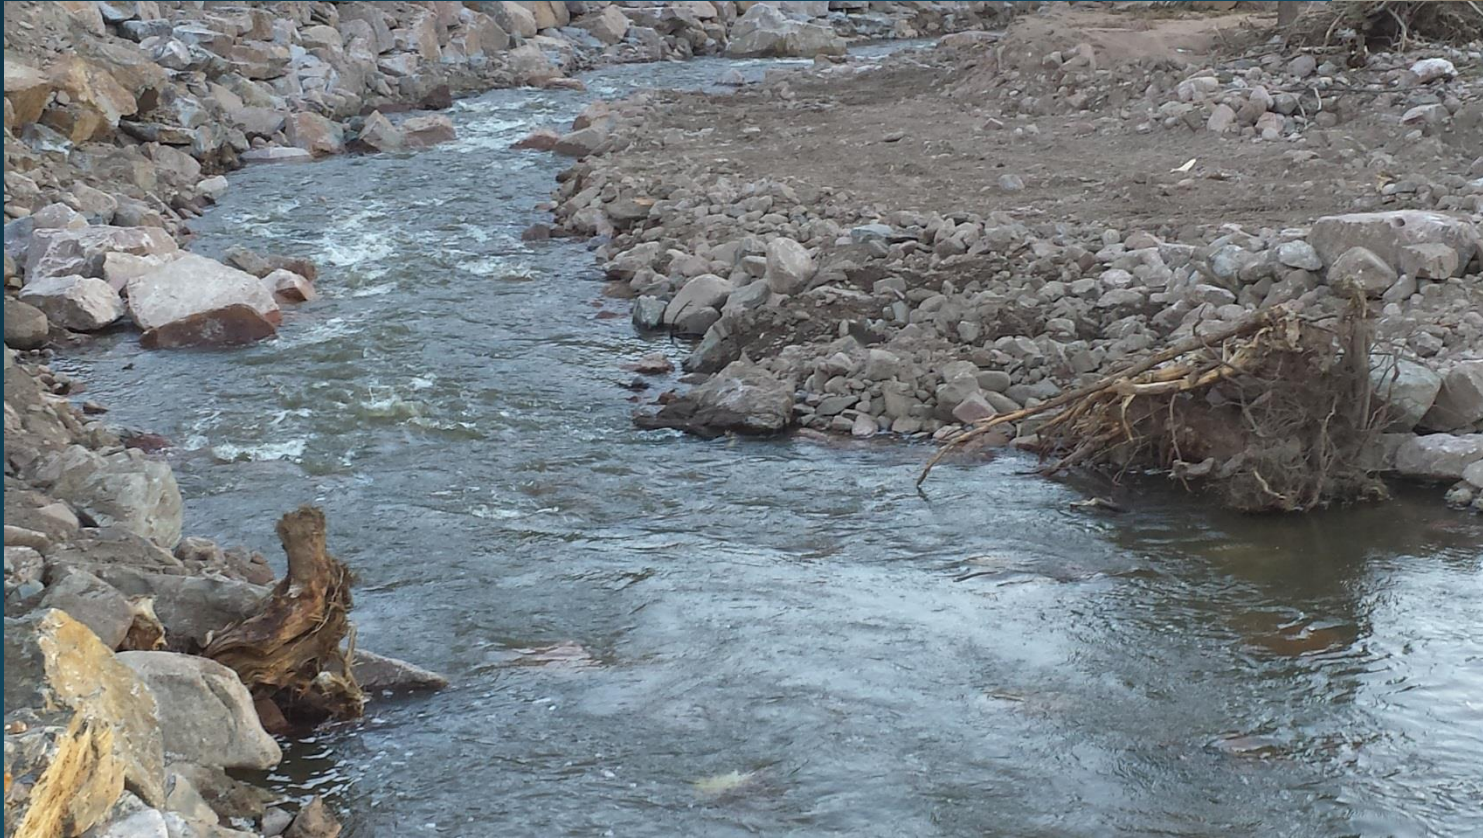
- Assist with Bank Stabilization
- Aid in silt deposition
- Create fish habitat
